## Test report

**Test report relating to a glass product according to European standard EN 1279-2, concerning the product marked as: Insulating Glass Unit, manufactured by: Zhengzhou Zhongyuan Silande High Technology Co., Ltd**

Report number	89205967-03 rev2
Date	18 August 2018
Author(s)	Mr. M.A.A.M. Schets, B.Sc.
Client	Zhengzhou Zhongyuan High Technolgy Co., Ltd. No.28, Dongqing West St. Zhengzhou Hi-tech Development Zone, 450001 China
Project number	89205967
Project name	14.A130 - EN1279-2
Number of pages	10

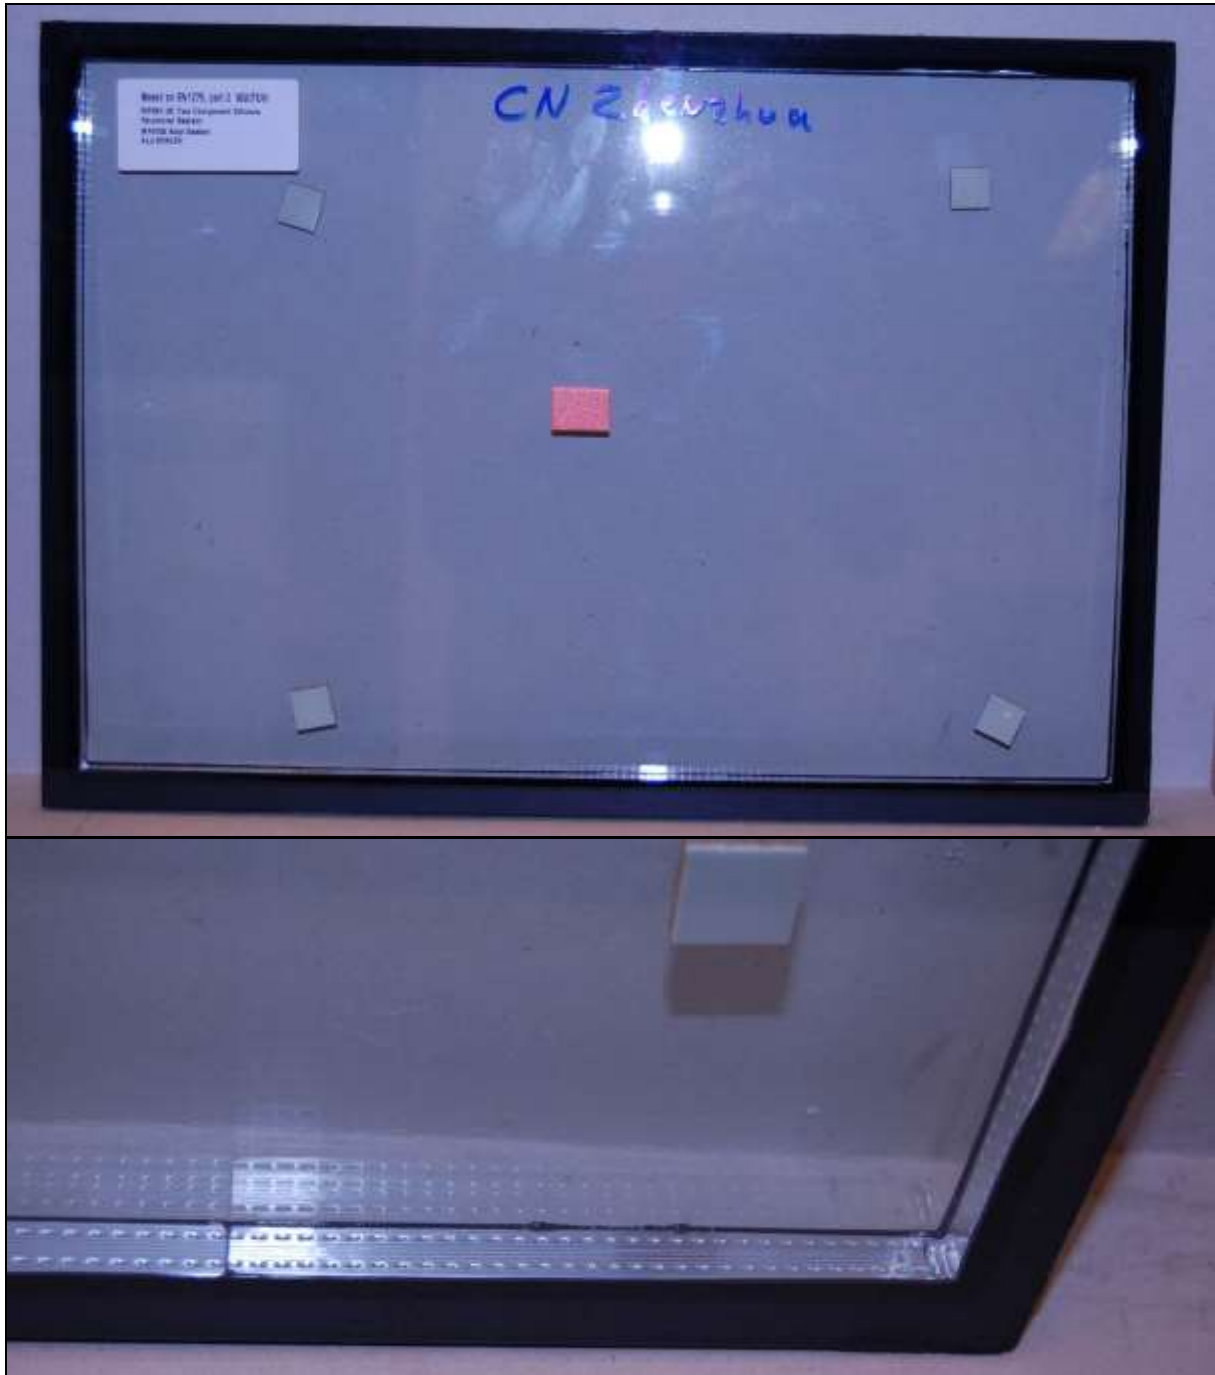
## Appendix B, Pictures of the tested object(s)

Type of glass	Clear float glass
Configuration of the samples	4-12-4 mm
DESICCANT	
Trademark / type of desiccant	FULONG / 3A
INNER sealant	
Trademark / type of inner sealant	SILANDE MF910G
Kind of inner sealant	polyisobutylene (butyl)
OUTER sealant	
Trademark / type of outer sealant	SILANDE MF881-25HM
Kind of outer sealant	silicone 2 component structural sealant
SPACER	
Trademark / type of spacer	SILANDE ALU.SPACER - BENDABLE 12A
Trademark / type of corners	bent
