## Test report

**Test report relating to a structural sealant according to ETAG 002 - Guideline for European technical approval for structural sealant glazing kits (SSGK) May 2012 - concerning the product marked as: MF899-25 Silicone structural sealant, manufactured by: Zhengzhou Zhongyuan Silande High Technology Co. Ltd**

Report number	89211669-01 Rev 01
Date	29 January 2018
Author(s)	Mr. M.A.A.M. Schets, B. Sc.
Client	Zhengzhou Zhongyuan Silande High Technology Co. Ltd No. 28 Dongqing West St Zhengzhou Hi-tech Industrial Development Zone, Henan China
Project number	89211669
Project name	16.A315 - ETAG 002
Number of pages	30

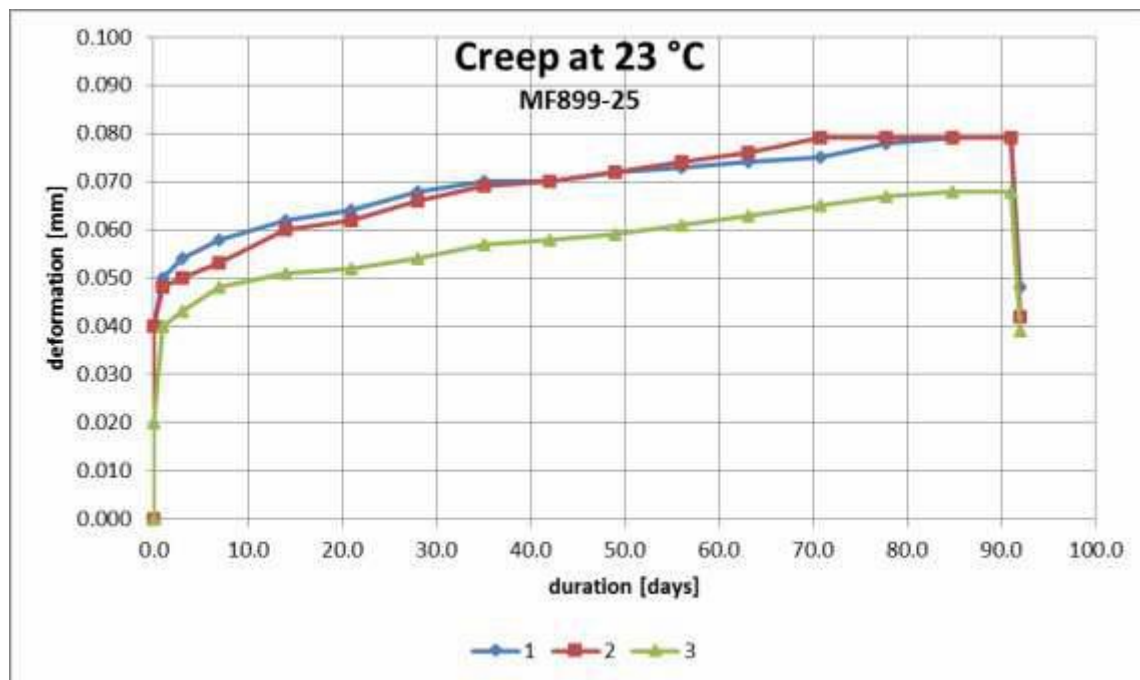
The creep installation subjects simultaneously the test specimens for 91 days to:

Specimen	After 91 days loading	after 24 h unloading
1	0.079	0.048
2	0.079	0.042
3	0.068	0.039
average	0.075	0.043

Figure 3: Creep sealant MF899-25 at 23°C

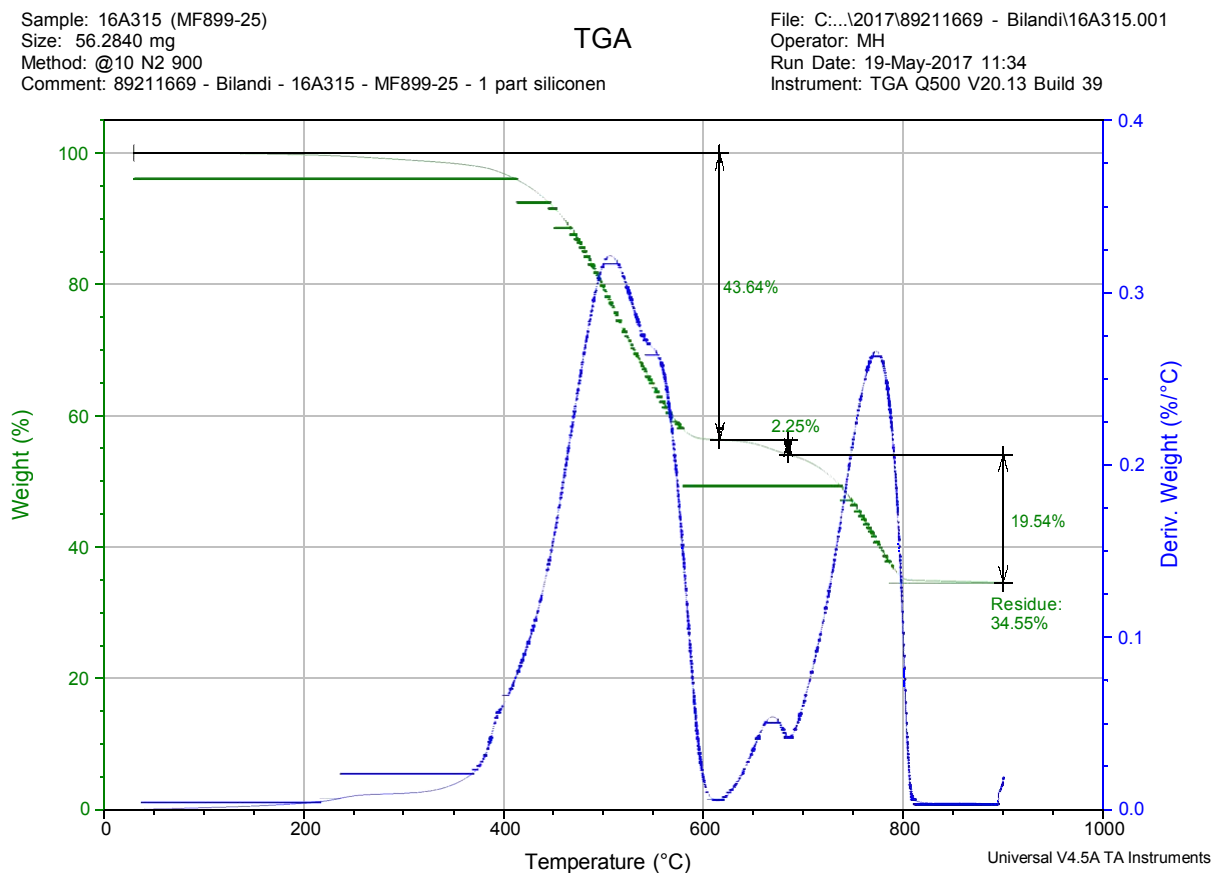
The relative weight loss with temperature (green curve) and first derivative (blue curve) is given in figure 2. There are two main decomposition steps. In the first step up to approx. 620 °C there is a weight loss of 43.6 %. The second double decomposition step consists of a small and a larger step. Up to approx. 685 °C there is a 2.3 % weight loss and up to approx. 685 °C another 19.5%. At 900 °C a residue of 34.6 % is left.

Figure 2: TGA curve, weight loss of MF889-25 Silicone structural sealant up to 900 °C.

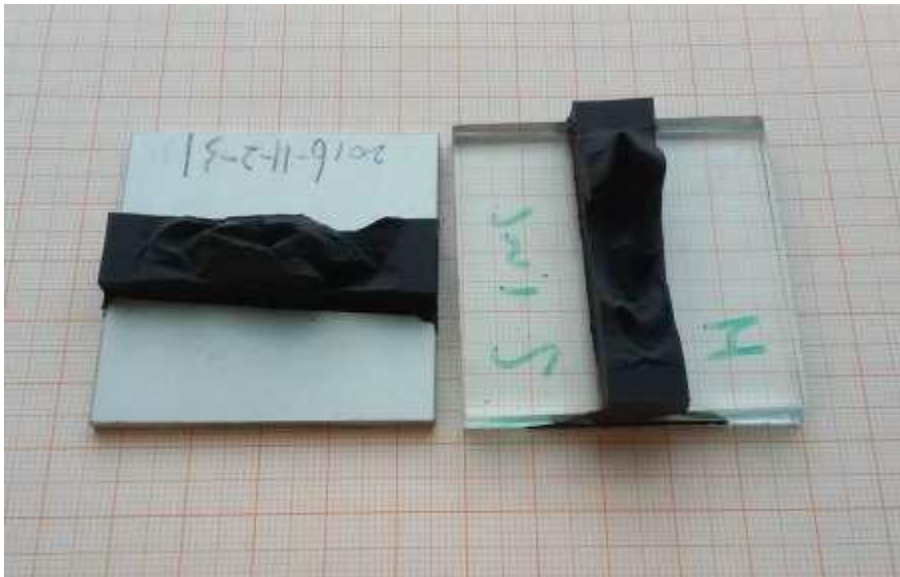
Sample type 1 (H-sample) typical failure pattern

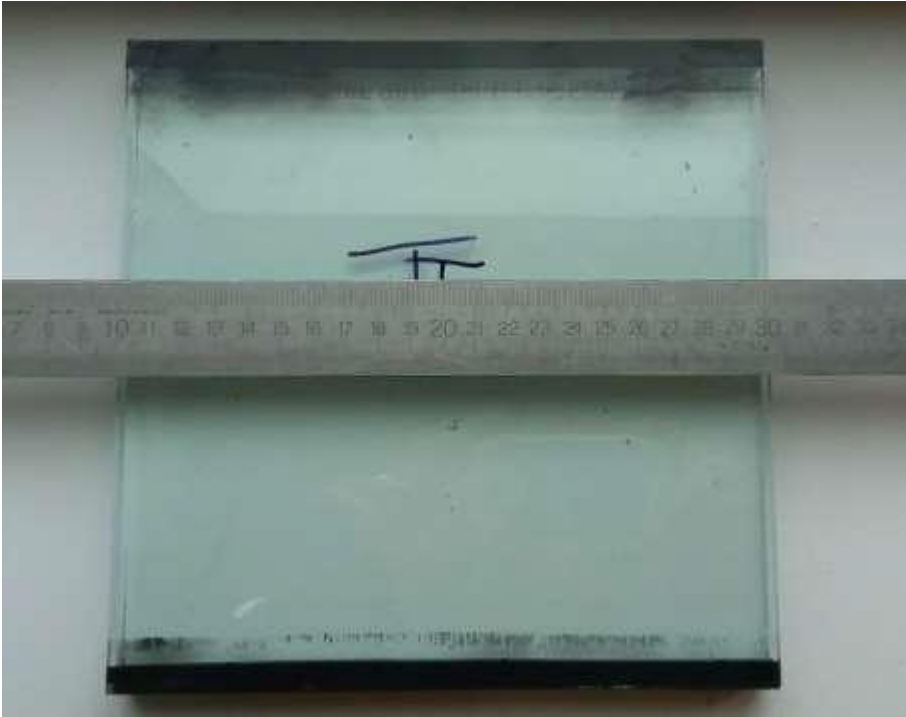
Sample type 3, creep behaviour

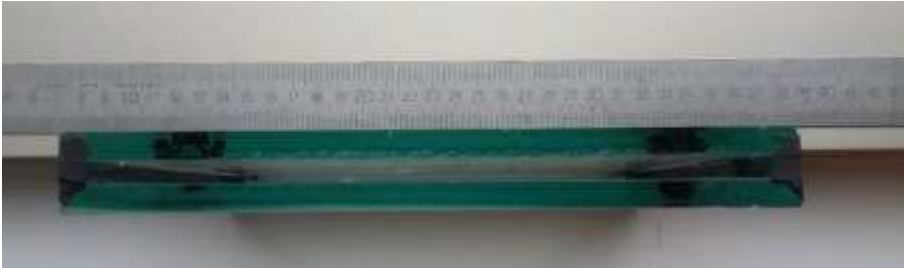
$e = 6.2-6.6 \text{ mm}$

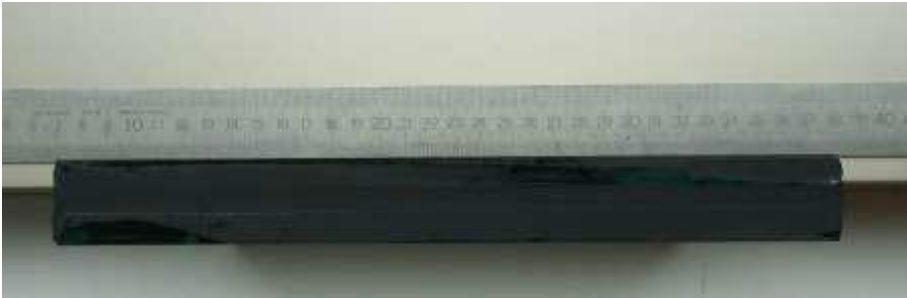
$L = 200 \text{ mm}$

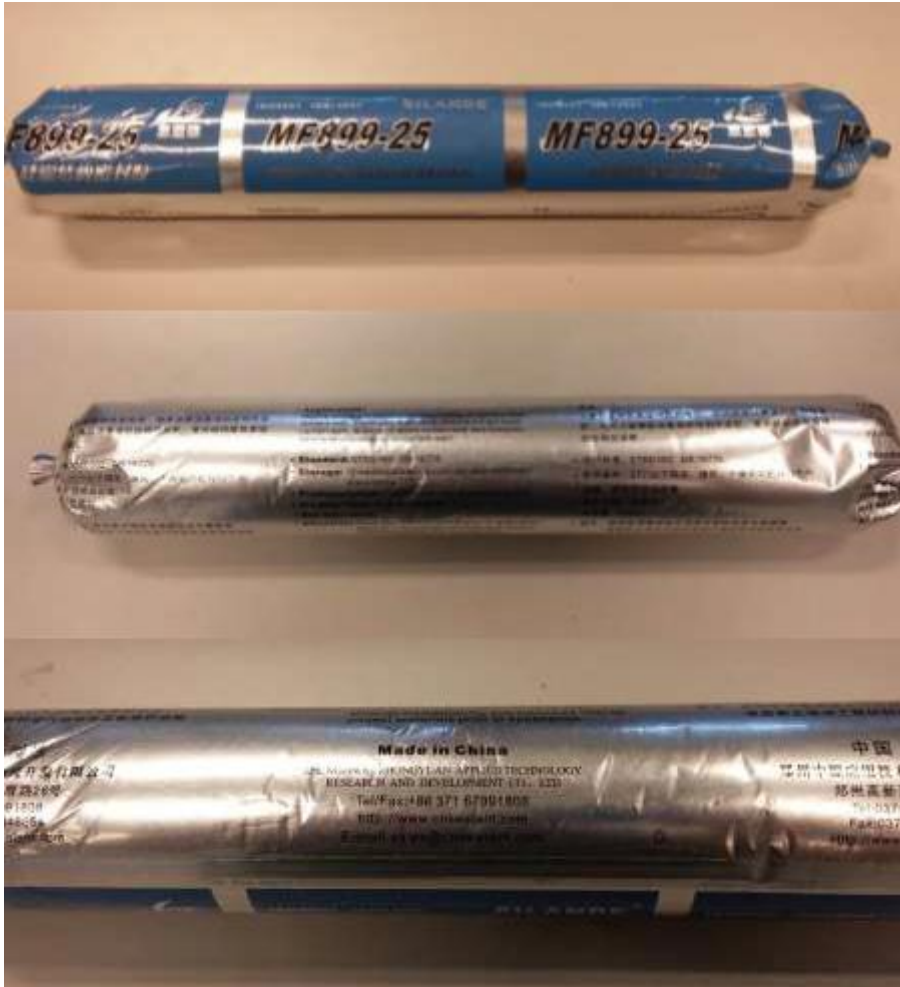
Tubes with sealant Silande MF899-25

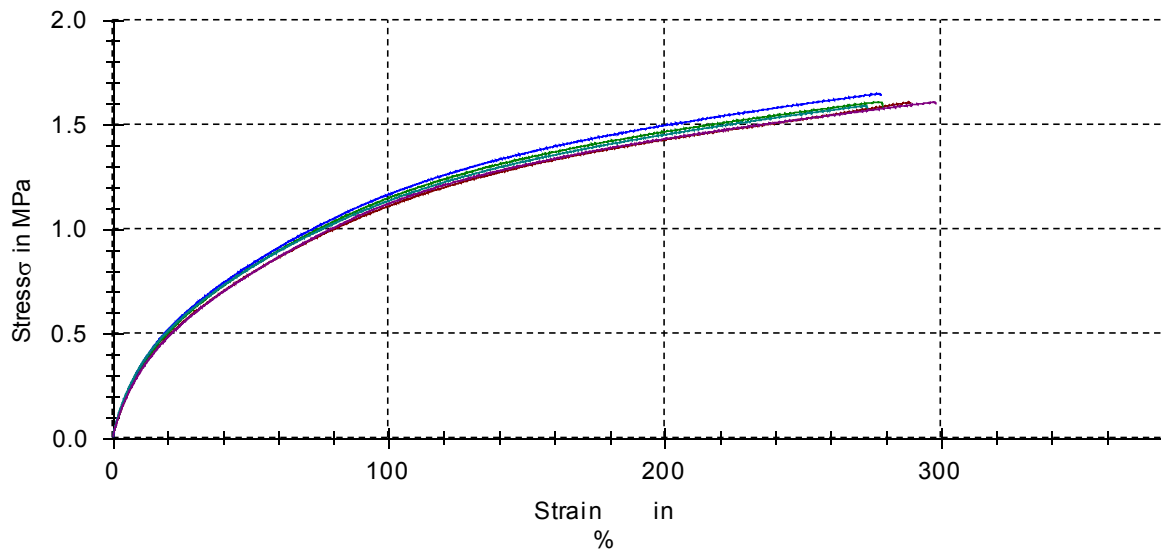
Tensile strength sealant after UV exposure.

The stress-elongation curves are represented in appendix C.
