**Test report relating to a structural sealant according to ETAG 002 - Guideline for European technical approval for structural sealant glazing kits (SSGK) May 2012 - concerning the product marked as: MF881-25HM Silicone, manufactured by: Zhengzhou Zhongyuan Silande High Technology Co., Ltd**

Report number	89205978-01 rev.02
Date	17 August 2018
Author(s)	Mr. M.A.A.M. Schets, B. Sc.
Client	Zhengzhou Zhongyuan Silande High Technology Co., Ltd No.28, Dongqing West St. Zhengzhou Hi-tech Development Zone, 450001 China
Project number	89205978
Project name	14.A141 ETAG 002
Number of pages	25

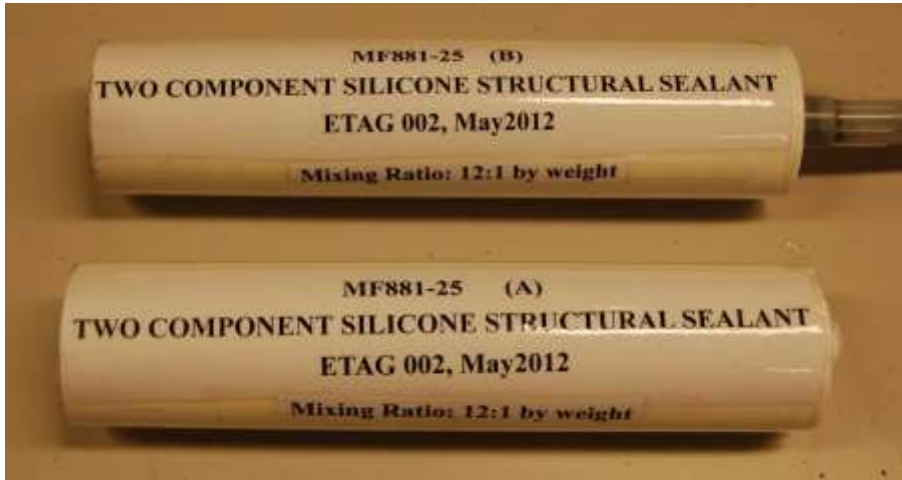
Tubes with sealant component MF881-25HM (A) and MF881-25HM (B)

With the separated components of MF881-25HM received from the client in tubes (see appendix A) a mixture of 12 parts A and 1 part B was made by hand mixing. A test specimen as in figure 1 was filled with the sealant mixture. The test specimen was stored at a standard atmosphere of (23±2) C° and (50±5) % RH for 21 days. Every each 7 days the test specimen was observed visually.

With the separated components of MF881-25HM received from the client in tubes ( see appendix A) a mixture of 12 parts A and 1 part B was made by hand mixing. Four open cylindrical rings with an internal diameter of 30 mm and 10 mm height were filled with the sealant mixture. The mass in air ( $m_3$ ) and in water ( $m_4$ ) of the filled rings was determined within 5 minutes after filling. Hereafter the test specimens were stored at a standard atmosphere of  $(23\pm 2)$  °C and  $(50\pm 5)$  % RH for 28 days and then stored in an oven at  $(70\pm 2)$  °C for 7 days. After 1 day conditioning at standard atmosphere the mass in air ( $m_5$ ) and in water ( $m_6$ ) was determined.
